# MONUMENT RECORD

Corner ID: **BeBI\_E15**

## Quarter Corner

Sections 19 & 20- T10N-R02W, 2nd P.M.

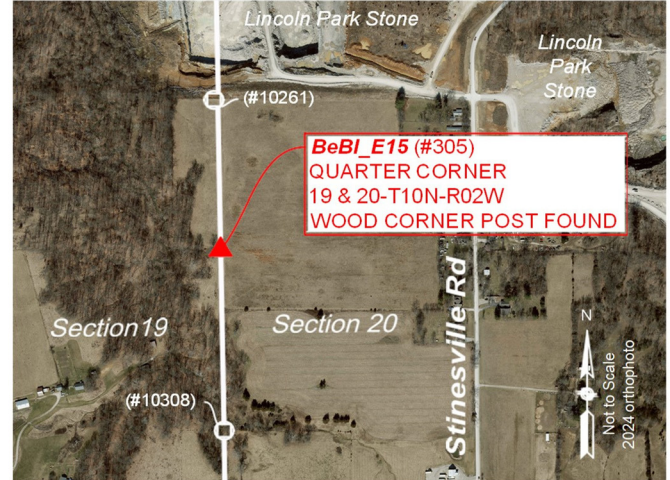
### MONUMENT LOCATION SKETCH:

**MONUMENT:** Describe monument set or found (Include material type, scribing, distance above/below grade, dimensions.) (#305) Wood Railroad tie post in concrete, at the corner of South and West bound fence lines. The west bound fence line begins with a gate attached to the post. The post has a Bynum Fanyo PLS capped rebar near its Northeast base.

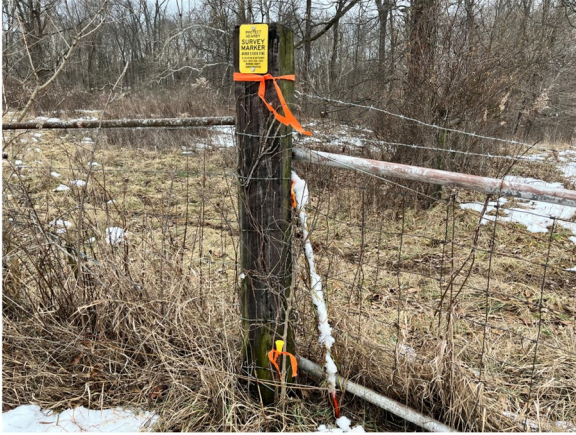
Photo Orientation & Description: From Northeast looking

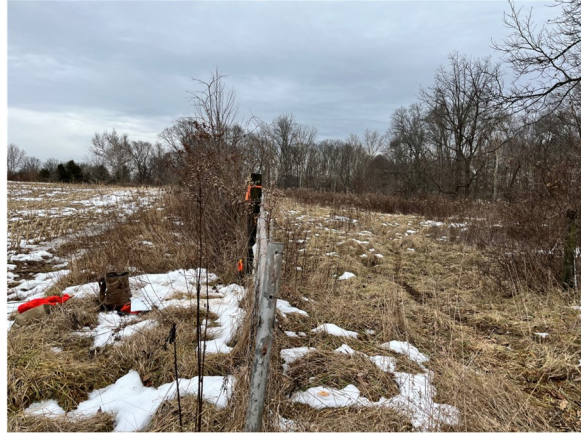
Photo Orientation & Description: From North looking South Southwest
